# DURACLUTCH INSTALLATION

## 15-510 DCG2-RANGER900-B

KIT PART #: 15-510

MODEL: DCG2-RANGER900-B

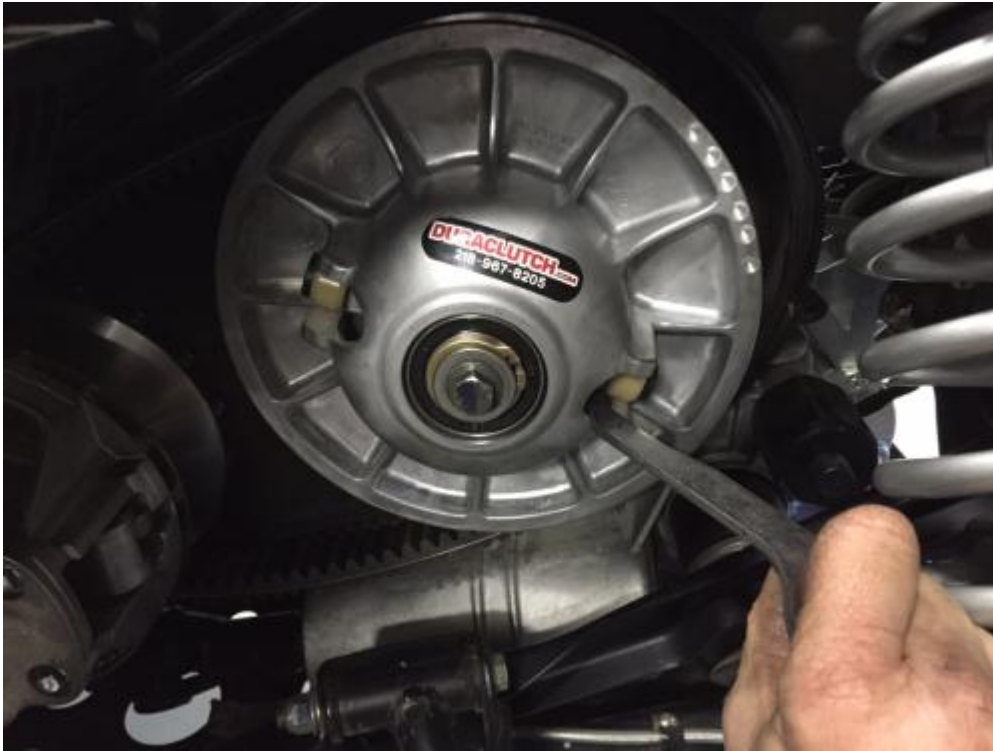
7. Install the Belt as follows if the Primary and Secondary are already installed. Place Belt in the Primary and open the Secondary sheaves with the Belt Installation Tool provided (see photo). Roll belt into the Secondary sheaves.

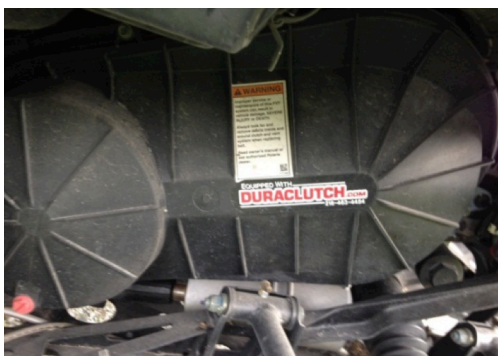
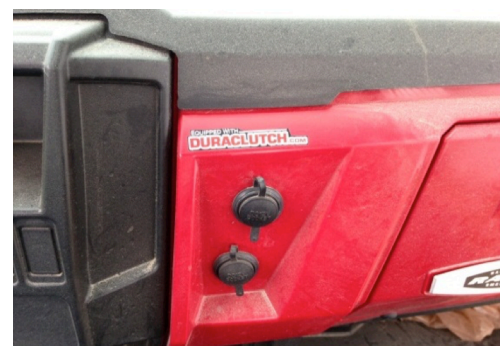
10. Apply two decals as shown – one on the clutch housing and one on the dash. Clean surface with alcohol or similar solvent. Decal application is important to alert service technicians that the standard Polaris clutches have been replaced.
